CUSTOMER: Hungarian Gas Storage Plc. (MFGT)
PRODUCTS: RUST GRIP®
MARKET: ENERGY & MINING
COUNTRY: HUNGARY (COURTESY OF NESCHVILL'97 Kft)
DATE: DECEMBER 2021

PROJECT DESCRIPTION

REFERENCE

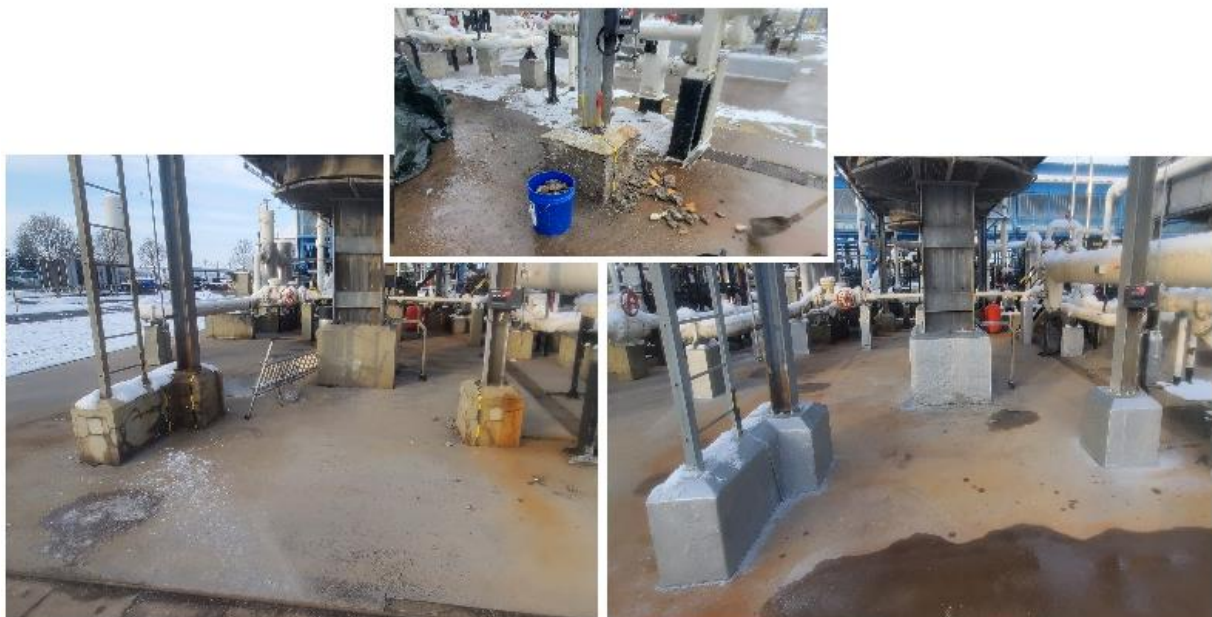
Concrete foundation soles needed repairing and strengthening due to high corrosion of the rebars. The problem beside corrosion is the vibration which the industrial cooling ventilators are causing. These vibrations created cracks and severe damage on the pipe holder concrete foundations.

BEFORE

AFTER

Treatment consisted of manually removing loose pieces of concrete. Next step was to apply 2 layers of RUST GRIP® with a roller. Subsequently the foundation pedestal could be restored with a cement mortar to regain its original shape. Finally, the concrete sole was completely encapsulated and protected with 2 layers RUST GRIP®.
